## Vernacular Craftsmanship in Sacred Space: Wooden Mosque Architecture of District Buner with Special Reference to Yakhdara Mosque

Sami Ul Haq

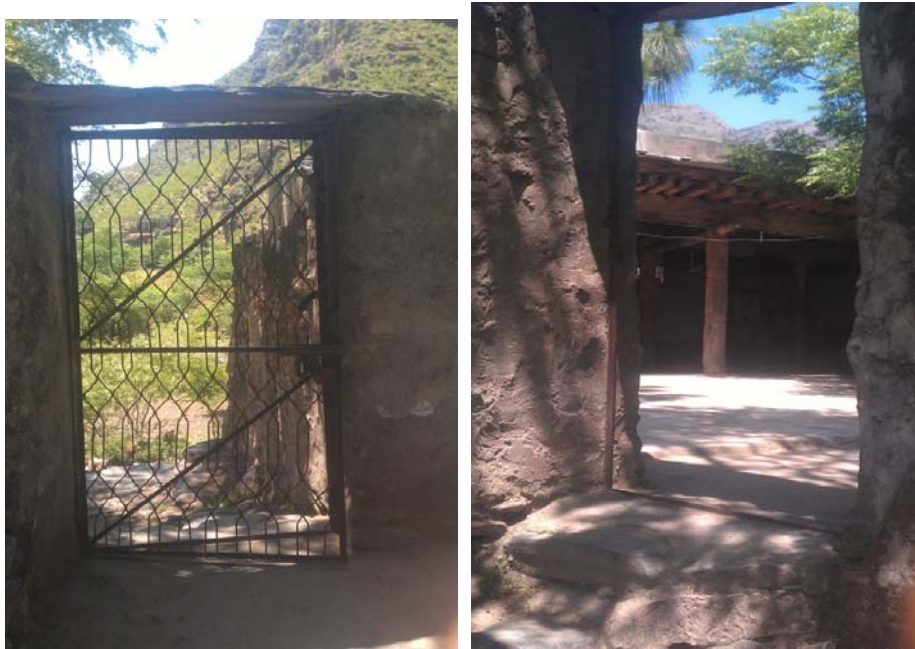
The principal entrance to the mosque complex is located on the northern side and consists of an iron-grilled gate set within cemented boundary walls (Figure 1). A dry riverbed occupies the ground immediately in front of the entrance, lending the approach a distinctive landscape character that differentiates this mosque from flat-site examples in valley settlements. The boundary walls were not original to the mosque structure. The first surrounding wall, constructed of dressed stone with mud mortar in local vernacular technique, was added in 1992 when community growth necessitated a defined precinct. Following partial destruction in the October 2005 earthquake, which caused widespread damage to historic fabric across Khyber Pakhtunkhwa (Ahmad, 2012), the walls were rebuilt using concrete block construction, introducing a material discontinuity that represents a significant alteration

**Figure 1:** Main entrance viewed from inside (left) and outside (right), showing the iron-grilled gate and cemented boundary walls; the dry riverbed is visible at the base of the approach

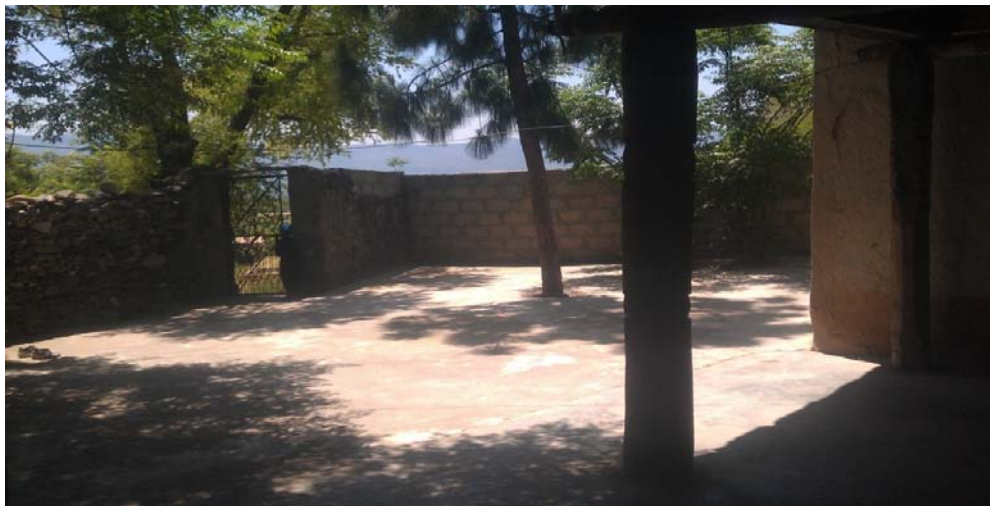
The western and northern walls of the prayer hall have been partially reconstructed in concrete block following earthquake damage, while remaining portions retain the original stone fabric laid in mud mortar (Figure 2). The junction between the two materials falls at the centre of the northern wall at the location of the entrance door, creating a legible material biography of the structure. Original stone wall thickness reaches approximately one foot, a mass that provided significant thermal inertia, stabilising interior temperature against the severe diurnal and seasonal temperature fluctuations of the mountain climate. The replacement concrete block measures only eight centimetres, substantially reducing this thermal mass. Wall heights are approximately seven feet.

**Figure 2:** Eastern and northern walls showing the junction between original stone-and-mud fabric (right) and later concrete block reconstruction (left)

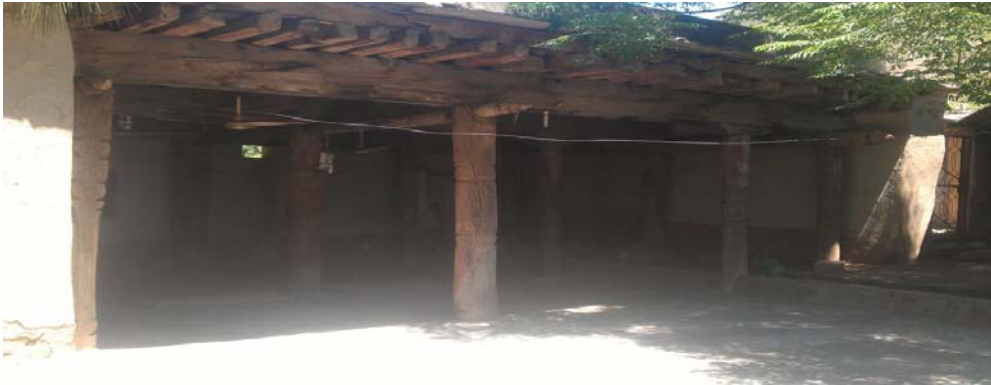
wall of the veranda (Figure 3). Both are constructed of stone with a mud plaster surface finished with stucco, a vernacular weather-protection technique widely used in the domestic architecture of the region that provides a durable, breathable, and visually refined surface (Oliver, 1997). Stone steps lift the base of the walls clear of the sloping hillside ground surface, preventing moisture ingress and providing the elevated platform character noted above (Figure 4).

**Figure 3:** *Eastern and southern walls viewed from the veranda, showing mud-plastered stone construction with stucco border finish*

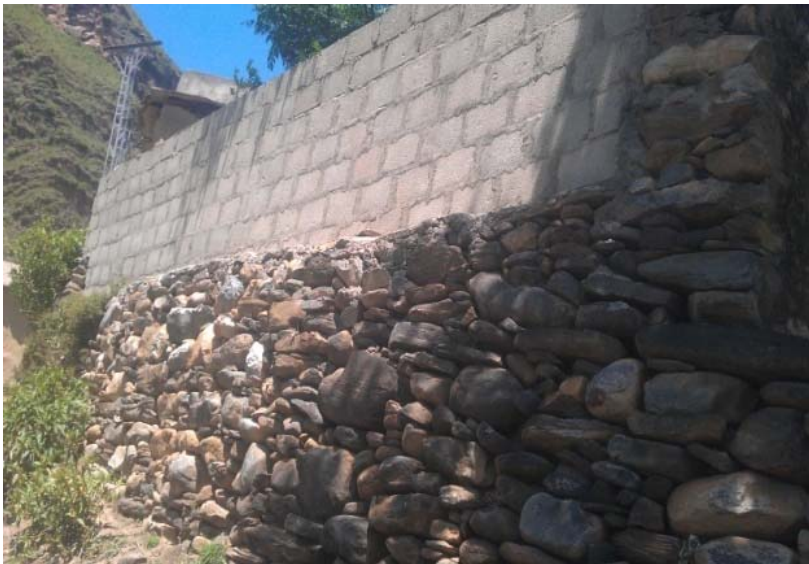
**Figure 4:** *Outer view of the boundary walls showing stone steps compensating for the sloping hillside terrain*

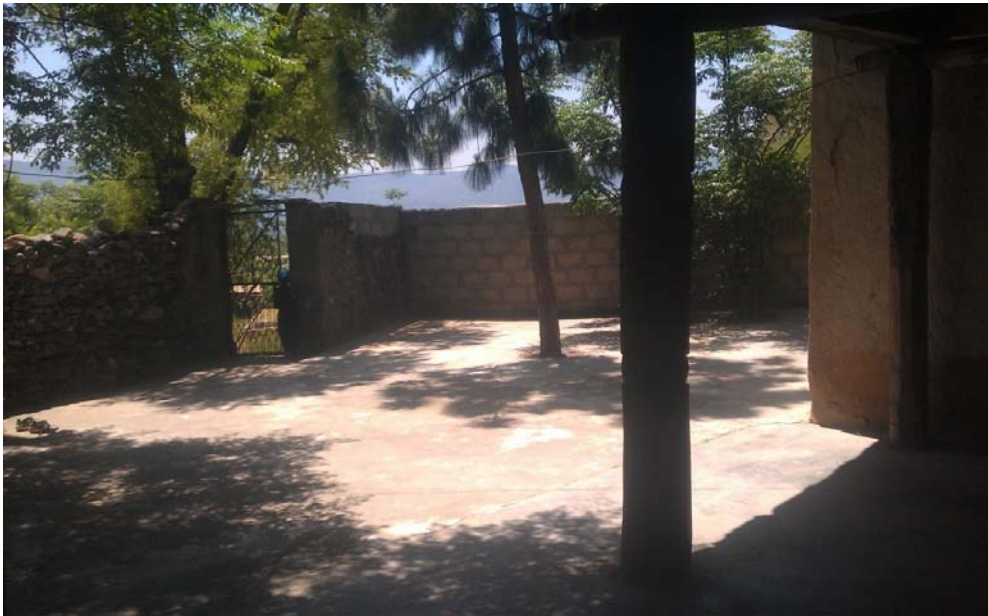
The courtyard is rectangular in plan, enclosed between the veranda on the west, the boundary walls on the north and east, and the ablution area to the south. It was fully paved with cement in 2006 following community decisions about maintenance and drainage (Figure 5). While the cemented surface has improved the practicality of the space for daily congregational use and ablution drainage, it has permanently eliminated any surviving evidence of the original ground treatment and has introduced a visually anachronistic hard surface inconsistent with the earthen and timber character of the historic structure. This type of well-intentioned but conservation-damaging intervention is widely documented at vernacular heritage sites lacking professional conservation guidance (Jokilehto, 1999; Ahmad, 2012).

**Figure 5:** *The cemented courtyard viewed from the veranda, showing the 2006 paving intervention*

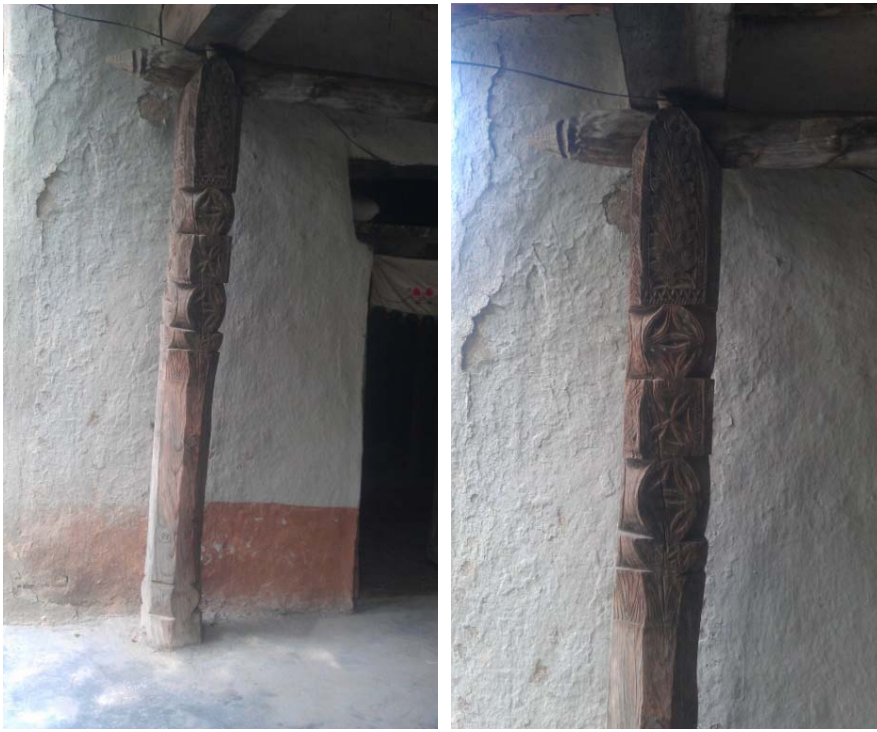
The first pillar retains carved rosette flowers, leaf motifs, garlands, and a geometric composition of four-petalled rosettes enclosing a central flower medallion. This programme is closely paralleled in the carved woodwork of the Odigram mosque and in Buddhist architectural carving from Gandhara sites in Swat, strongly suggesting a continuous regional ornamental tradition adapted from pre-Islamic to Islamic sacred contexts (Scerrato, 2007; Rehman, 2003). Comparable rosette-and-garland programmes appear on mosque columns in Chitral documented by Darling (1988), confirming the inter-regional coherence of this decorative vocabulary across the Hindu Kush.

**Figure 6:** First pillar of the 1st row: front face (left) and northern face (right) showing carved rosette flowers, leaf garlands, and four-petalled medallion, the most complete surviving decorated surface in the mosque

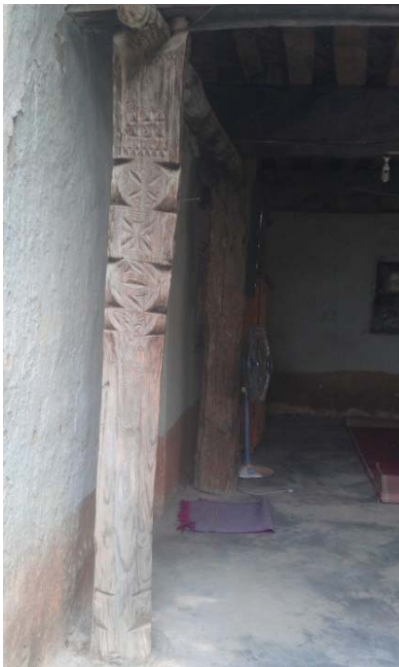
**Figure 7:** Northern face detail of the 1st pillar, 1st row, showing the differentiated decorative programme applied to the upper shaft, evidence of the craftsman's attention to multi-face composition

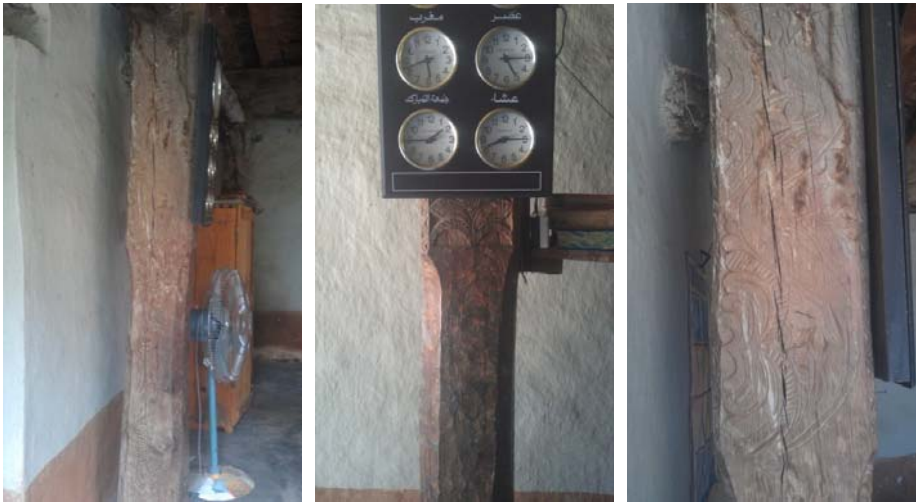
The second pillar has suffered catastrophic loss of its carved surfaces (Figure 8). According to community informants, the northern face originally carried a programme of interlinked branches bearing flowers, a naturalistic motif paralleled in Mughal decorative arts and in the wood carvings of Dir mosques. This surface is now almost entirely obliterated by weathering. More damagingly, the front face has been permanently obscured by a large clock screwed directly into the carved timber, a careless

intervention that covers the majority of the carved field and represents an irreversible loss to the monument's decorative integrity. The deliberate removal of this clock, with careful repair of fixing holes, should be among the first priorities of any future conservation programme.

**Figure 8:** Second pillar of the 1st row: front face with clock fixture obscuring carved surface (left); northern face showing traces of branching flower motif (centre, right), the clock represents an entirely reversible but as yet unreversed loss

1. Immediate removal of the clock fixture from the second veranda pillar, with careful documentation of any carved surface revealed, and urgent stabilisation of all carved timber surfaces against further deterioration.

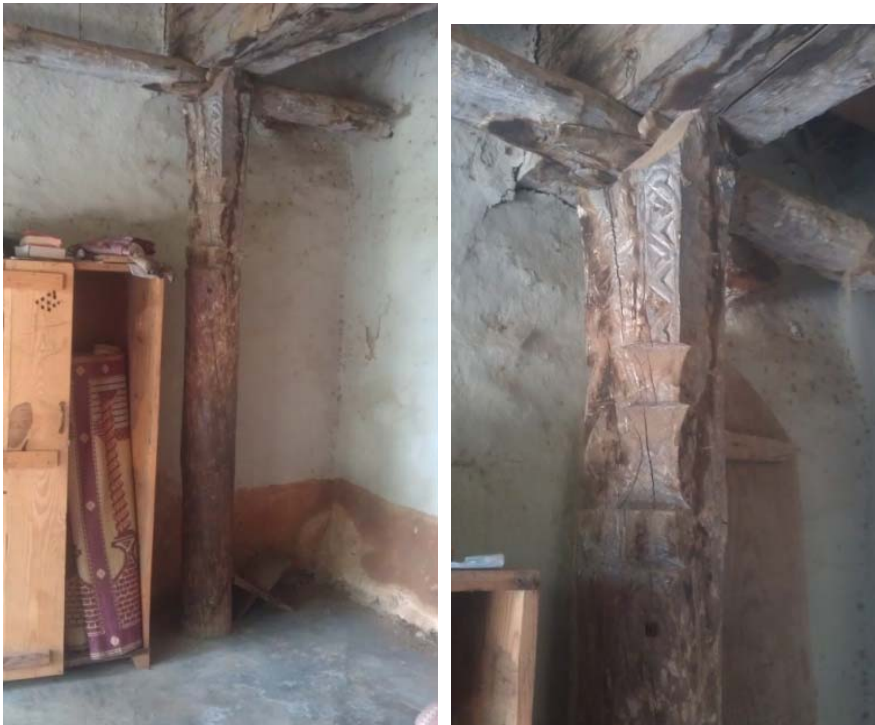
The third pillar has been entirely plastered with lime over its original carved surface, leaving only vestiges of vertical zig-zag incised lines visible at the top of the shaft (Figure 9). This irreversible intervention, undertaken presumably to stabilise a deteriorating surface, has permanently concealed whatever decorative programme the column originally carried. The loss of the carved surfaces of this pillar cannot be undone without specialist investigation, though ground-penetrating imaging techniques might in principle reveal underlying forms.

**Figure 9:** Third pillar of the 1st row: lime-plastered surface with only traces of zig-zag incised lines surviving at the shaft head

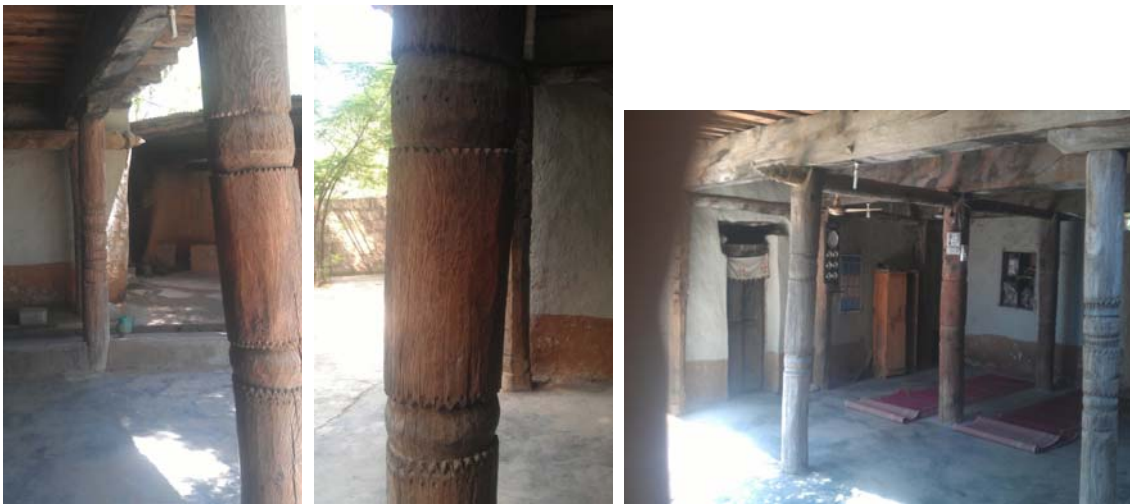
The first pillar of this row displays two pairs of zig-zag incised lines with rows of small circles between them, producing a rhythmic geometric pattern with clear parallels in Islamic geometric ornamentation. The second and third pillars carry simpler zig-zag line programmes without the circle element (Figure 11). The consistency of the zig-zag vocabulary across all three pillars indicates a single craftsman or workshop responsible for the original set, probably produced for the Dewana Baba mosque in the late nineteenth or early twentieth century.

**Figure 10:** First pillar of the second row (three views): round section shaft with zig-zag and circle incised decoration, transferred from Dewana Baba mosque c.1975

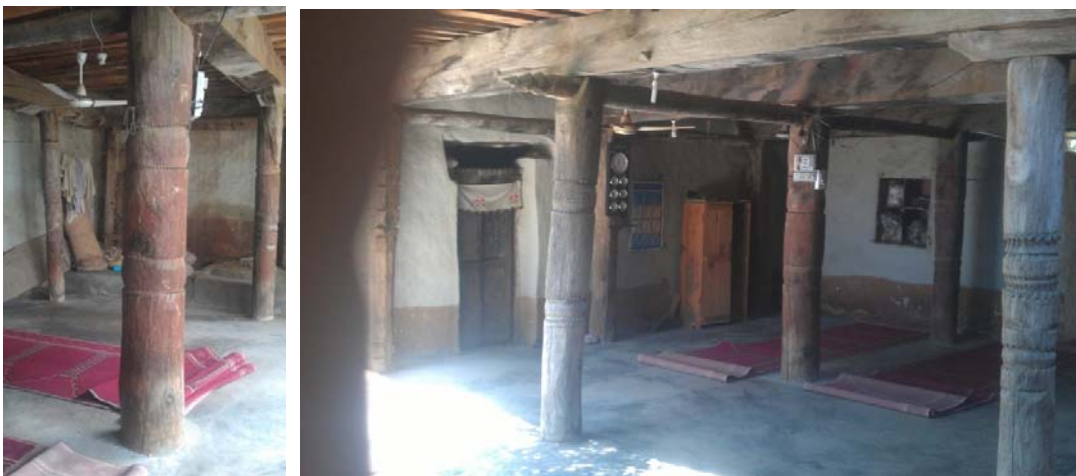
**Figure 11:** Second pillar of the second row (left) and general view of the second row (right), showing the consistent zig-zag decorative vocabulary

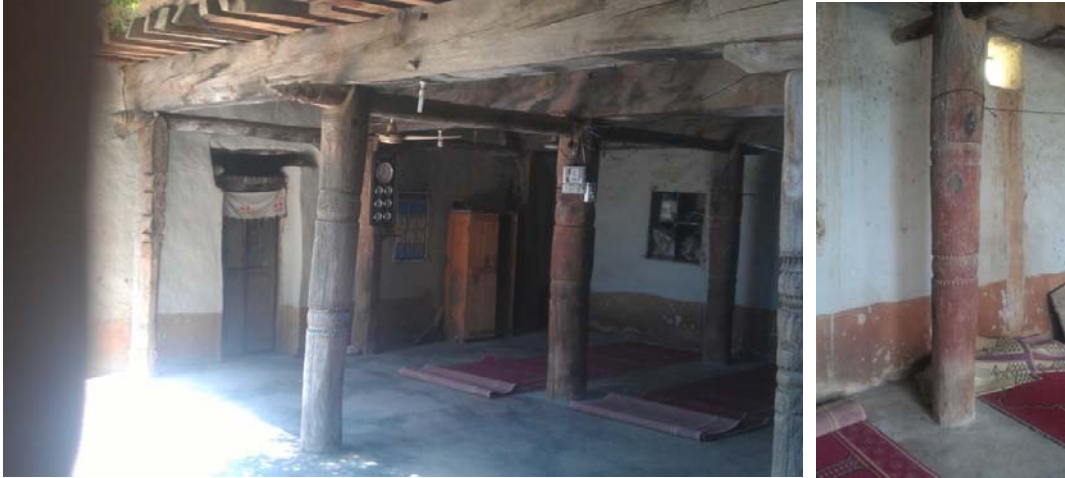
**Figure 12:** Third pillar of the second row of the veranda (two views), showing round section and zig-zag incised ornament

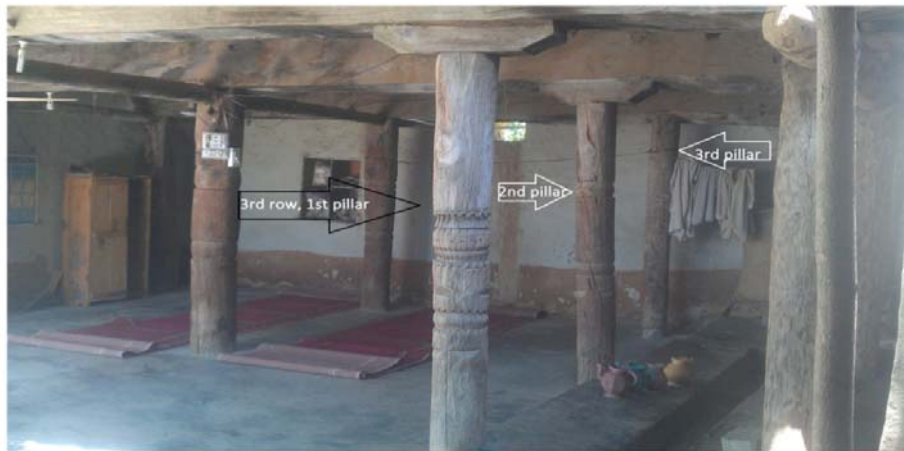
The third-row pillars are round in section and fitted with simple non-voluted capitals, a design feature connecting this mosque to related vernacular column traditions documented across the Hindu Kush (Bianca, 2000; Darling, 1988). The first pillar displays a zig-zag and circle programme, while the second and third carry only zig-zag lines (Figure 12, 13). These pillars function not as primary roof supports but as intermediate stabilising elements within the veranda frame, reflecting a sophisticated structural logic that distributes lateral loads through the timber frame system.

**Figure 13:** All three pillars of the third row of the veranda, showing the consistent non-voluted capital detail and zig-zag decoration

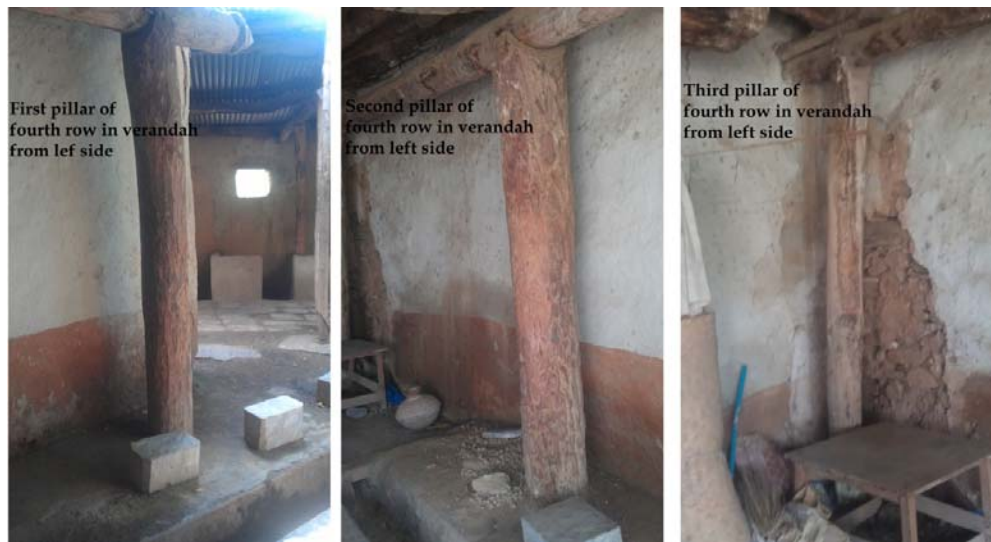
The fourth row was added during the 2000 restoration campaign to consolidate the structural stability of the western wall of the veranda roof (Figure 14). All three pillars are plain, undecorated round shafts devoid of any carved ornament or capital detail. This absence of decoration is not a stylistic choice but a symptom of the near-total loss of traditional woodcarving skills from the local community by the late twentieth century. The stark contrast between these plain columns and the elaborately carved first-row pillars immediately adjacent, separated by perhaps one century of craft knowledge erosion, which is among the most eloquent material arguments for the urgency of conservation action and craft skills revival in the region (Oliver, 1997; Jokilehto, 1999).

**Figure 14:** All three pillars of the fourth row of the veranda, added in 2000: plain, undecorated round shafts standing in stark contrast to the carved columns of the first row immediately adjacent

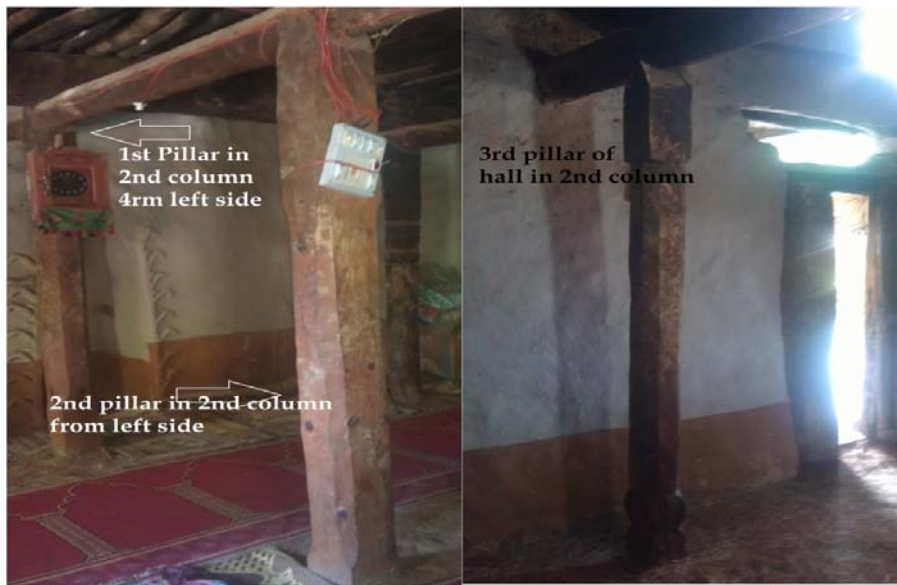
The second or central row of hall pillars comprises rectangular-section elements added in 2000 (Figure 16). Community informants reported that these pillars were produced by workers without specialised woodworking training, a circumstance confirmed by their less accomplished profiles and the absence of any finishing detail. This represents a clear and documented moment of craft knowledge rupture, in which the community was unable to source craftsmen capable of producing columns to the standard of their predecessors (Jokilehto, 1999).

**Figure 16:** Second column of hall pillars: rectangular-section elements added in 2000, showing less accomplished workmanship reflecting the loss of specialist craft skills

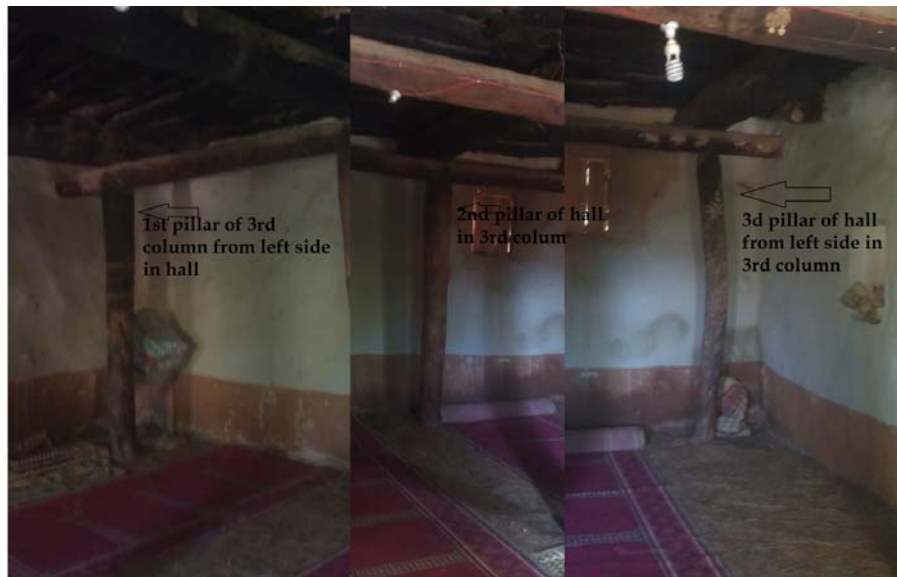
The third row contains round pillars donated by a community member in 1998 and installed in 2000 (Figure 17). Their surfaces bear clear traces of fire blackening, indicating prior use as structural columns in a kitchen or domestic cooking space. This form of material improvisation, in which structurally sound but ceremonially inappropriate elements are incorporated into a sacred building for functional necessity, reflects the resource constraints of community-managed heritage maintenance and parallels documented practices in vernacular mosque construction across South Asia (Frishman and Khan, 1994).

**Figure 17:** Third column of hall pillars: round shafts donated in 1998, showing fire-blackening from prior domestic use as kitchen structural columns

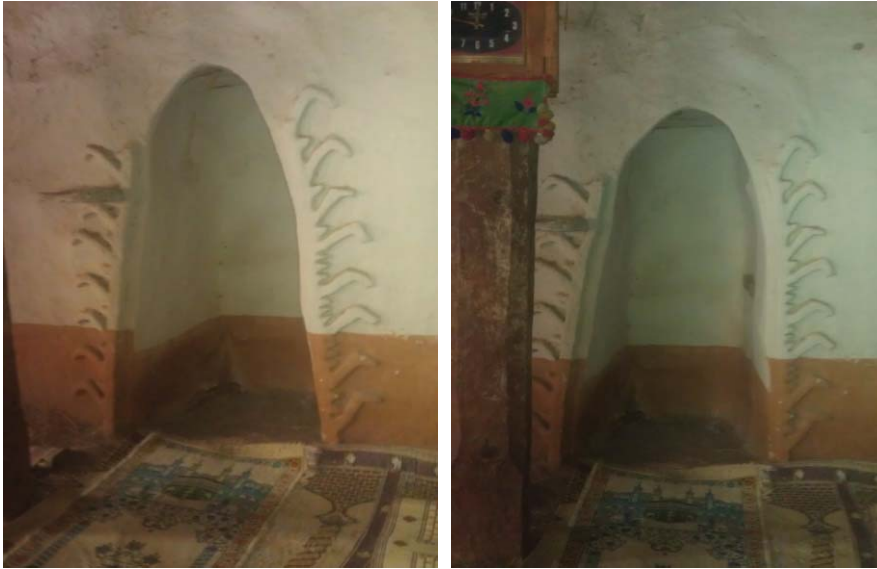
The prayer hall is oriented toward the qibla (the direction of Mecca, approximately west-southwest from this location) with a single mihrab niche set in the western wall (Figure 18). The mihrab is constructed of mud, the primary vernacular material for interior architectural features in the region, and is distinguished by raised-relief hook-like ornamental motifs applied to the external wall surfaces surrounding the niche by local women in 2000. This form of female participation in mosque ornamentation through the application of domestic vernacular craft techniques to sacred spaces is a distinctive feature of Pashtun community mosque culture documented across the region and reflects a specifically gendered mode of contribution to the sacred built environment that has received limited scholarly attention (Khan, 2009). A stone ledge set to the left of the mihrab preserves the material memory of candlelit prayer before electricity reached the valley.

**Figure 18:** *The mihrab in the prayer hall western wall: mud construction with raised-relief ornament applied by community women in 2000 (left, right), and stone candle ledge*

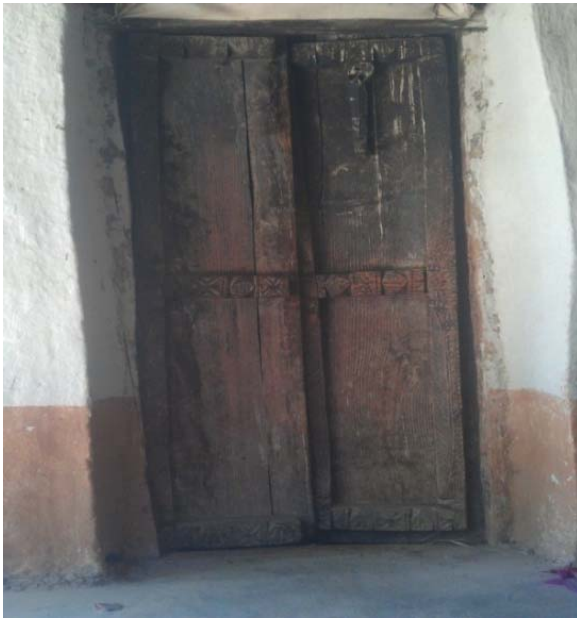
The principal door of the prayer hall is a double-leaf timber construction that represents the oldest surviving joinery element of the mosque and one of the most technically accomplished woodworking achievements on the site (Figure 19). Each leaf measures approximately six and a half feet in height by two feet in width, constructed of ranzra, one of the region's principal joinery hardwoods, valued for its density, durability, dimensional stability, and workability (Khan, 2009; Hussain et al., 2013). The survival of this door in reasonable functional and aesthetic condition, despite a structural age of at least one century in a mountain environment of extreme temperature variation and high humidity, demonstrates the exceptional material performance of ranzra for architectural applications in this climate zone.

**Figure 19:** *The main door of the prayer hall: double-leaf construction in ranzra hardwood, the oldest surviving joinery element of the mosque*

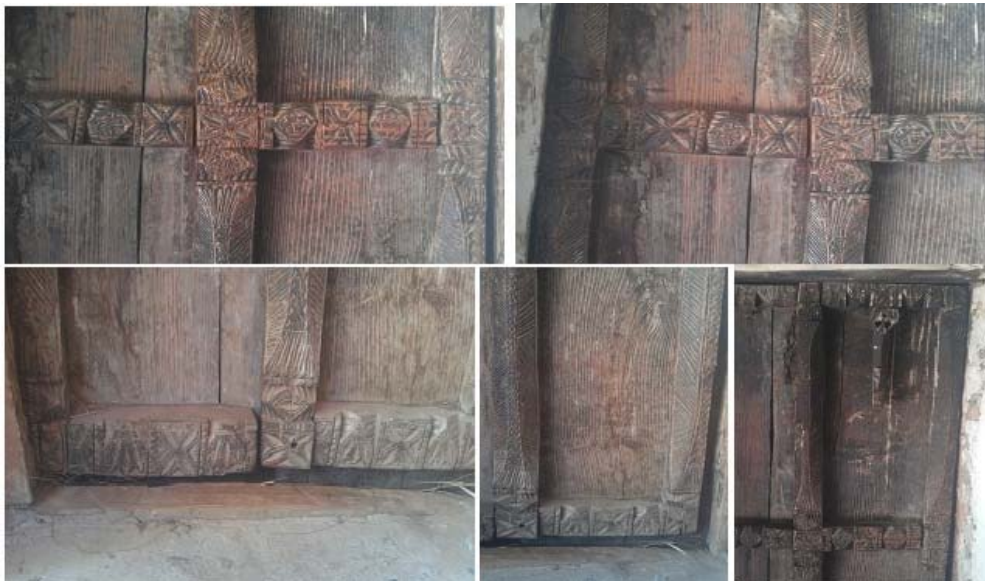
The door frame carries a carved decorative programme of rosette flowers, leaf scrolls, and zig-zag banding (Figure 20) that is formally and iconographically consistent with the ornamental programme of the first-row veranda pillars. This coherence between the door and the oldest surviving columns strongly suggests contemporaneous production, either by the same craftsman or by the same workshop tradition, providing important evidence for dating the original construction phase of the mosque. The correspondence also demonstrates the unity of the original decorative conception of the building, in which a consistent visual language was applied across structural and non-structural elements by craftsmen working within a shared ornamental system.

**Figure 20:** *Carved decoration on the main door frame: rosette flowers, leaf scroll, and zig-zag banding consistent with the decorative programme of the original veranda columns*

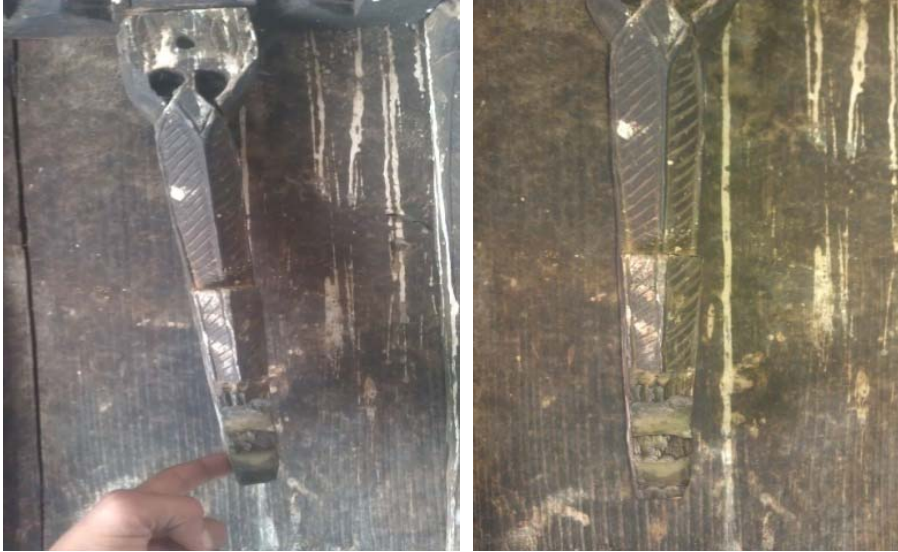
The right side of the door frame retains an indigenous wooden locking mechanism fixed to the upper frame by a dart-and-slot system, with the lock body itself decorated with leaf and line carved motifs (Figure 21). Traditional wooden locks of this general type, combining structural function with

decorative elaboration, have been documented in vernacular buildings across the Hindu Kush and Karakoram regions (Oliver, 1997; Darling, 1988) and are now extremely rare survivals, as metal padlocks have almost universally replaced them. The Yakhdara example is therefore of considerable scholarly significance as one of very few extant specimens of this craft in situ in a religious building.

**Figure 21:** *The indigenous wooden locking mechanism on the right door frame: dart-and-slot fixing with leaf-and-line carved ornament, a rare in-situ survival of a vanishing craft tradition*

Third, the survival of the indigenous wooden door lock, one of very few remaining in-situ specimens in a religious building in the region, representing a technology that has already effectively disappeared from living craft practice and survives only as an archaeological artefact. Its presence at Yakhdara therefore marks the extreme end-point of the craft transmission chain: the point at which traditional knowledge has passed entirely from practice into heritage.

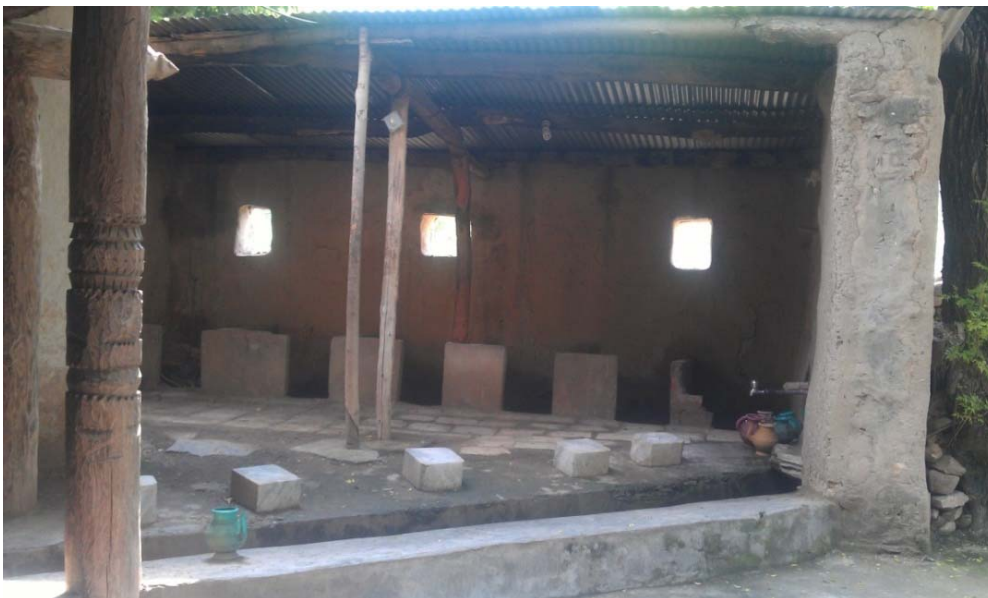
The ablution veranda is positioned at the far left (southern) corner of the main veranda, integrated within the veranda structure rather than being housed in a separate pavilion (Figure 22). This arrangement, which can accommodate approximately fifteen worshippers simultaneously performing ritual purification, reflects the traditional planning logic of small community mosques in the region, where ablution and prayer spaces are conceived as elements of a continuous processional sequence from the public exterior through graduated zones of sacred space to the prayer hall interior (Hillenbrand, 1994; Frishman and Khan, 1994). The spatial integration of ablution within the veranda avoids the need for a separate enclosed structure and is climatically appropriate to the mild summer conditions of the valley.

**Figure 22:** *The ablution veranda at the left corner of the main veranda, showing its integration within the veranda structure*

The integration of the ablution space within the veranda structure, rather than in a separate pavilion, representing an elegant vernacular solution to the canonical requirement for purification before prayer, adapted to the limited resources and intimate scale of a mountain community. The positioning of the mihrab in the western wall, the orientation of the prayer hall toward the qibla, and the communal character of the flat-roofed veranda as a gender-differentiated overflow prayer space during peak attendance all confirm the mosque's full functional compliance with Islamic spatial norms implemented through specifically local material and constructional means (Creswell, 1958; Hillenbrand, 1994).

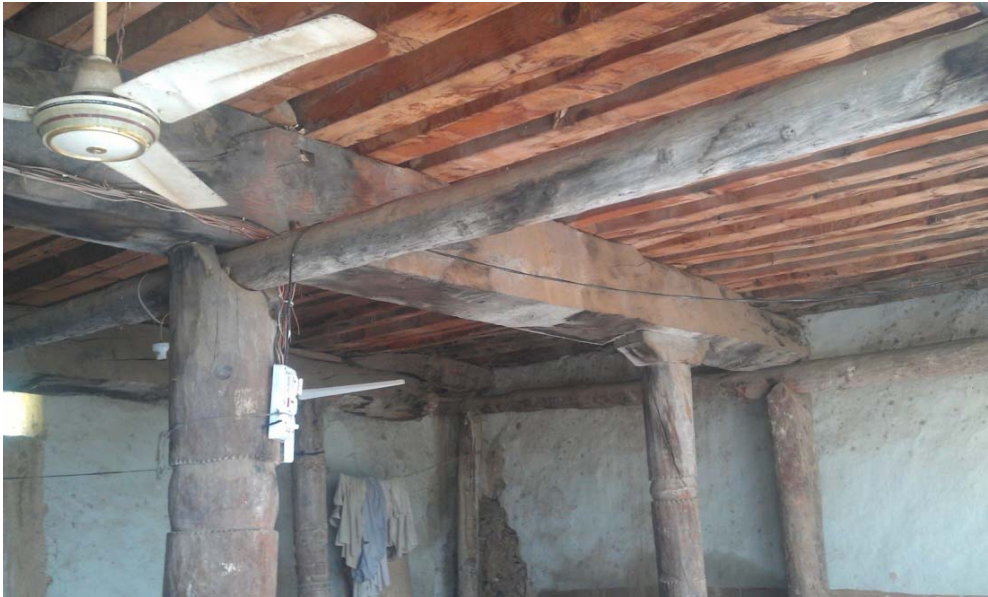
The roof structure of both the veranda and the prayer hall employs the flat timber roof system standard to vernacular architecture across the semi-arid highland zones of the Hindu Kush-Karakoram belt: a grid of square-section primary beams spans between the supporting columns, carrying a secondary layer of smaller timber planks that form the ceiling soffit and roof deck (Figure 23). A compacted layer of earth and gravel above the plank deck provides insulation, weatherproofing, and the additional thermal mass characteristic of traditional flat roofs in this climate zone (Bianca, 2000; Oliver, 1997). This construction system requires a low maintenance regime, principally re-compaction of the earthen layer and inspection of beam ends for decay, which is well suited to the resources of a small rural community.

**Figure 23:** *The flat timber roof structure of the prayer hall, showing primary beam grid and secondary plank deck*
